Augmented Speed Enforcement System Prototype Development

Task Number: 2062

Warning System for Vehicles Speeding in Work Zones

Smart traffic drums detect speeding vehicles to improve safety in work zones

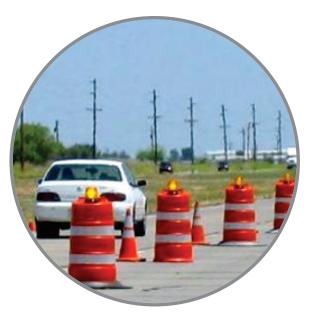
The smart drums are placed next to orange traffic cones to indicate the work zone lane closure. The drums flash and send a warning signal when they detect a vehicle exceeding the speed limit.

Caltrans, in partnership with the Montana State University Western Transportation Institute (WTI), developed a warning system consisting of 28 orange smart drums positioned adjacent to orange cones to mark the work zone lane closure. When the system detects a vehicle that is exceeding the speed limit, the orange lights on top of the drums flash, warning the driver to slow down. The flashing lights also alert workers that a vehicle is speeding through the work zone. If the vehicle speed is above a set speed, the system activates a pager system that also warns the workers of the speeding vehicle. The researchers tested the smart traffic drum system for four weeks on SR 152 near Los Banos.
